WESLEY METHODIST EPISCOPAL CHURCH  
662 Washington Street  
Bath  
Sagadahoc County  
Maine

MHBR No. 119

MAINE HISTORIC BUILDING RECORD (MHBR)  
WESLEY METHODIST EPISCOPAL CHURCH  
MHBR NO. 119

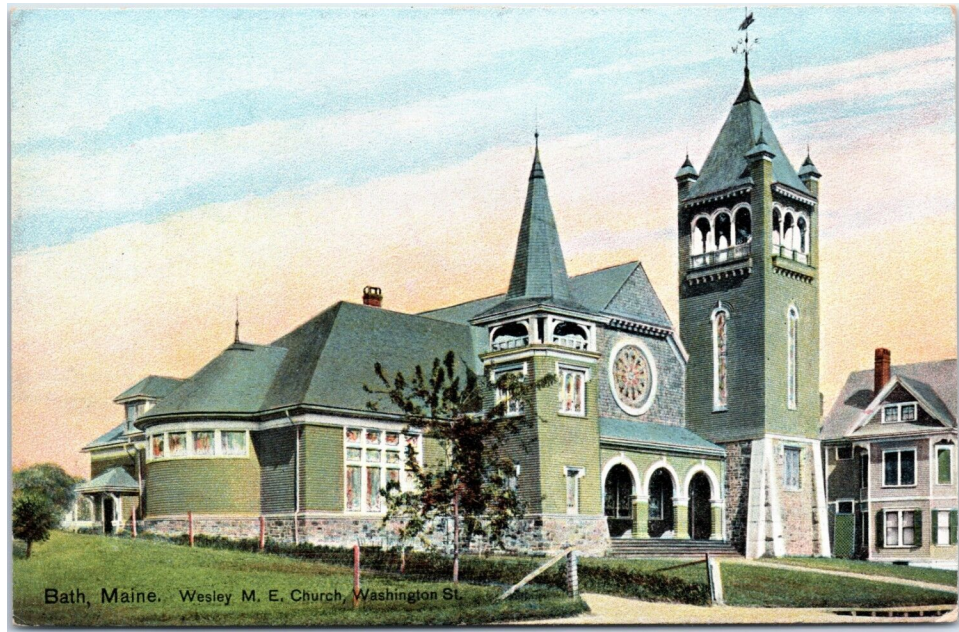
Undated, early postcard view. In this image, the dormer and entry at the west block are visible.
